MASTER PLAN

HARTFORD BOTANICAL GARDEN AT COLT PARK

December 3, 2007

Limited Condition Survey (BVHIS)

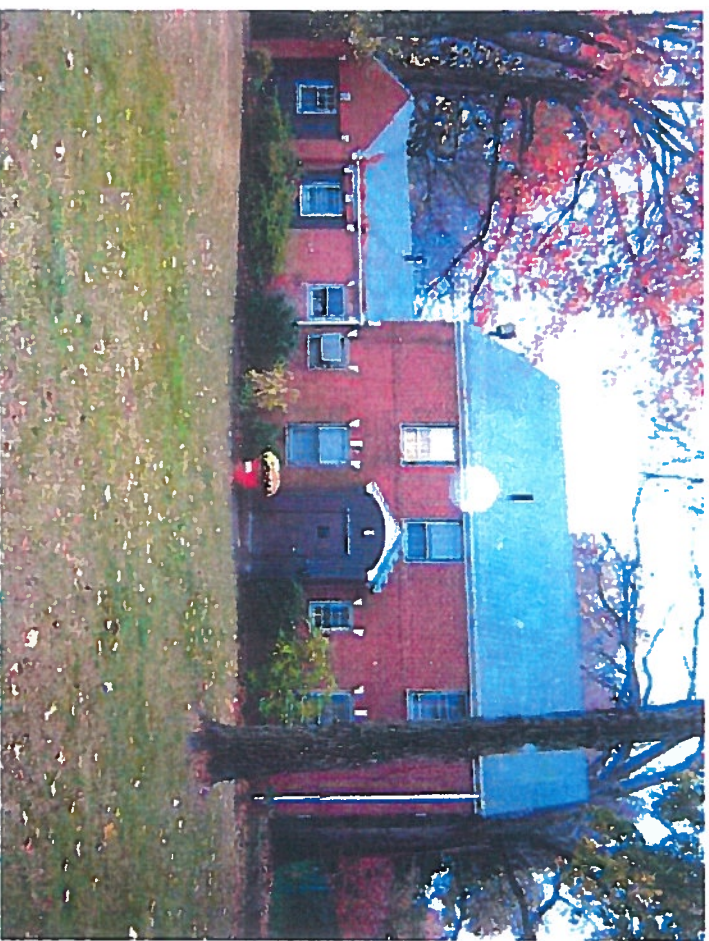
A-1 The former residence now a business faces Stonington Street. The garage and connector are part of the store. The brick masonry exterior has a few cracks from settlement in the connector.

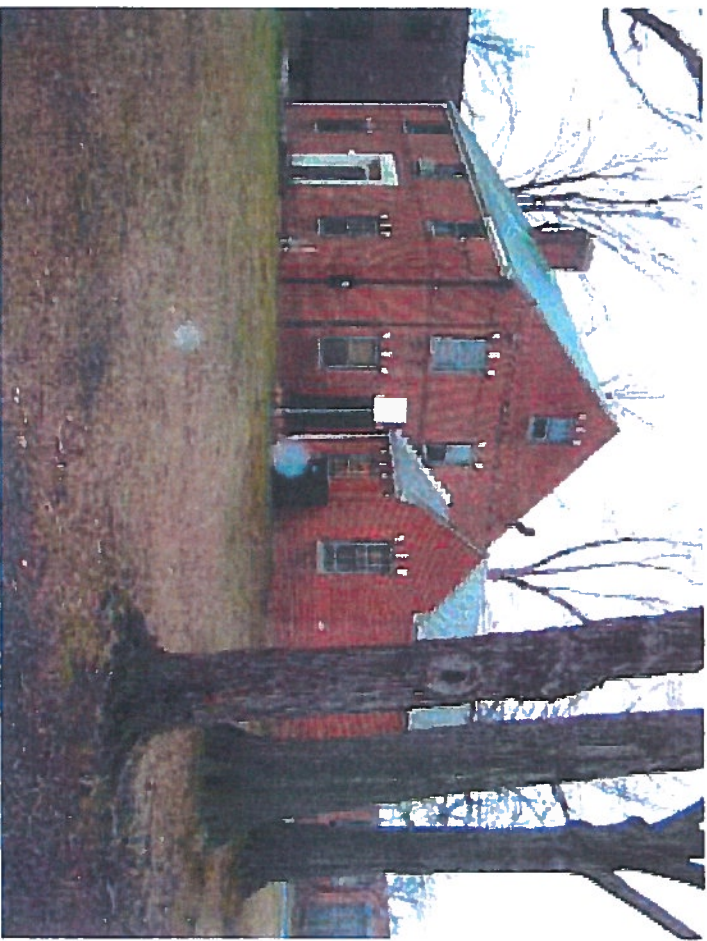
A-2 The electrical service and site lighting are mounted to the face of the building.

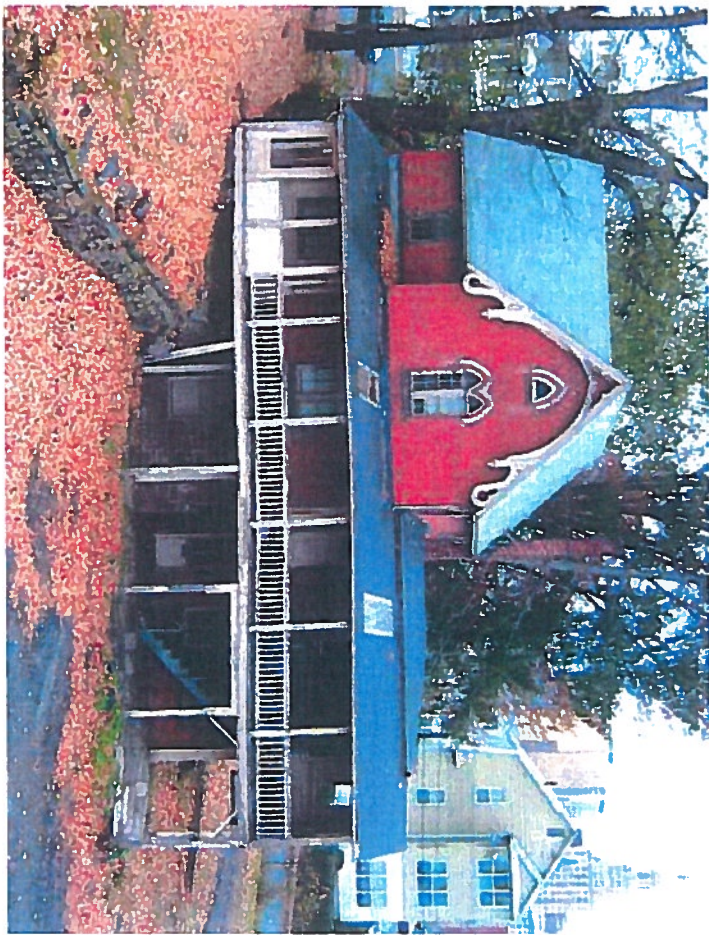
B-1 The Gardener's House is slowly falling apart. The porch is at a point where it should be replaced.

- Replace the existing wood porch on the south side with a new structure, matching the profile of the existing.
- Adjust the grading and walks to provide for an accessible entrance at the front door as well as the porch floor.
- Replace missing and damaged brick, and repair isolated cracks in masonry. Repoint 10-50%.
- Repair window frames. Replace wood sash with new sash, matching the profile.
- Replace, repair and repaint all exterior wood trim
- Replace roof shingles (within 5 years).
- Replace flashing and roof on east wing with new adhered membrane.
- Replace/repair aluminum gutters and downspouts. Provide splash blocks at ground level.

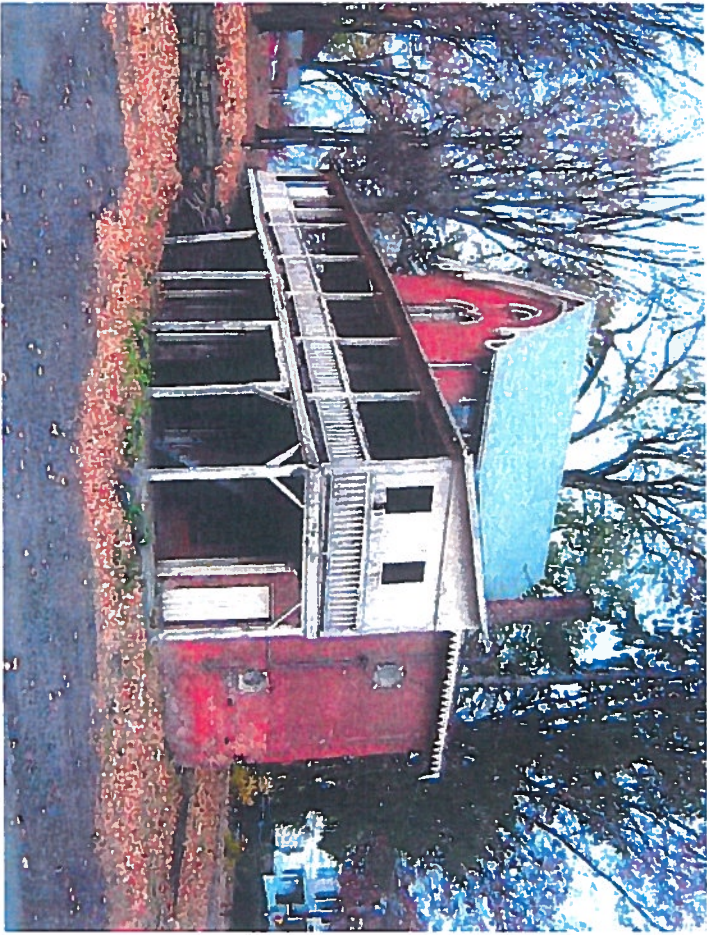
B-2 The brick masonry exterior is unraveling and cracking in several areas.

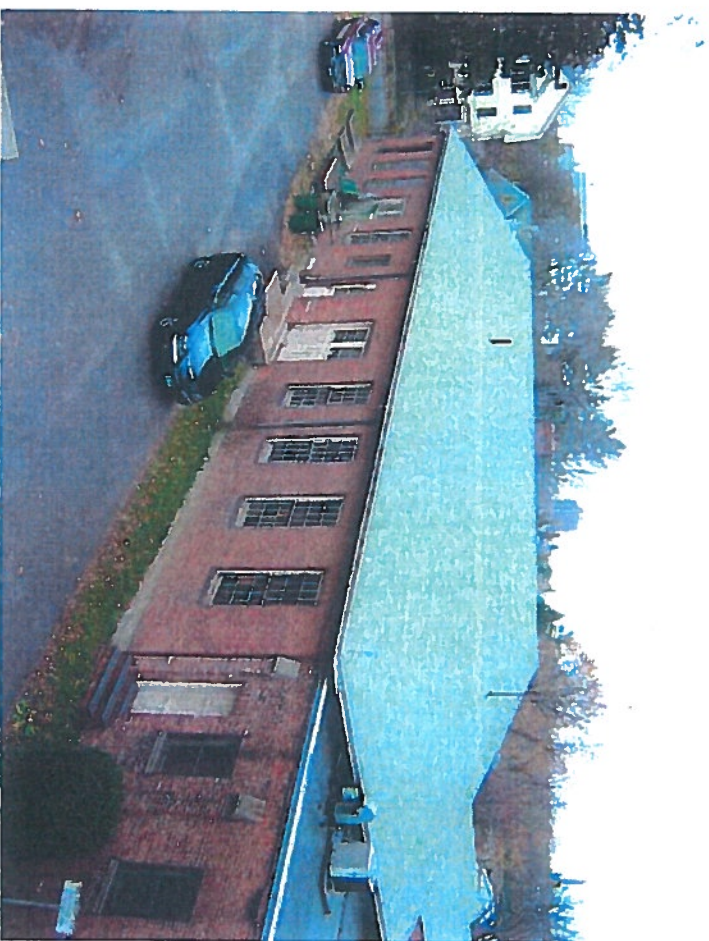
C-1 The Maintenance Building described in this report is only a portion of the total building. The hip roof seen in this view along with the flat roof to the right are the portions discussed here.

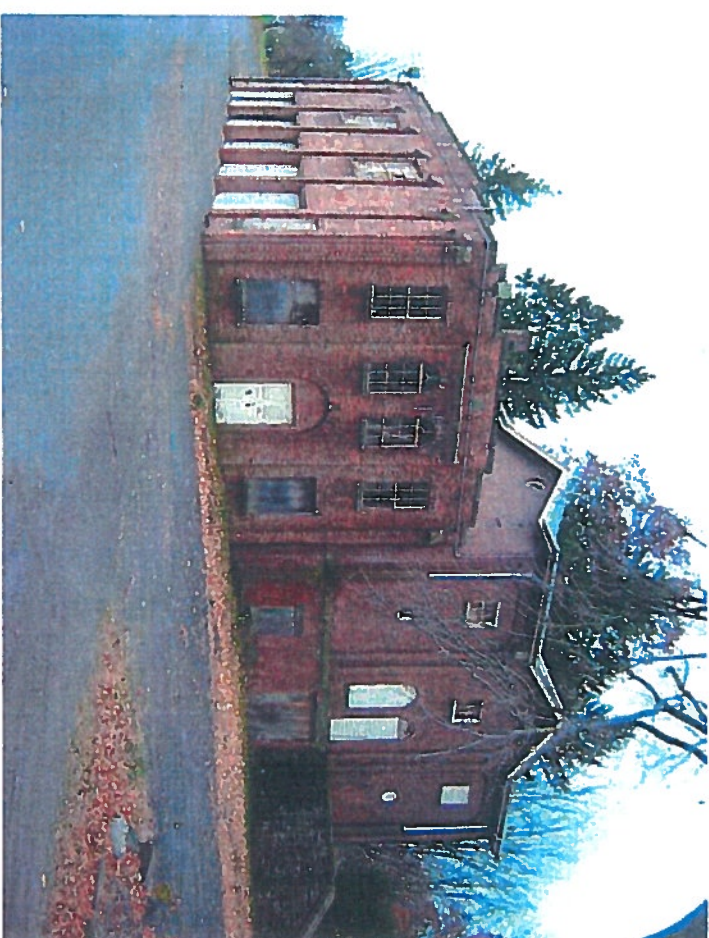
D-1 The original Carriage House was added onto and is in need of repairs.

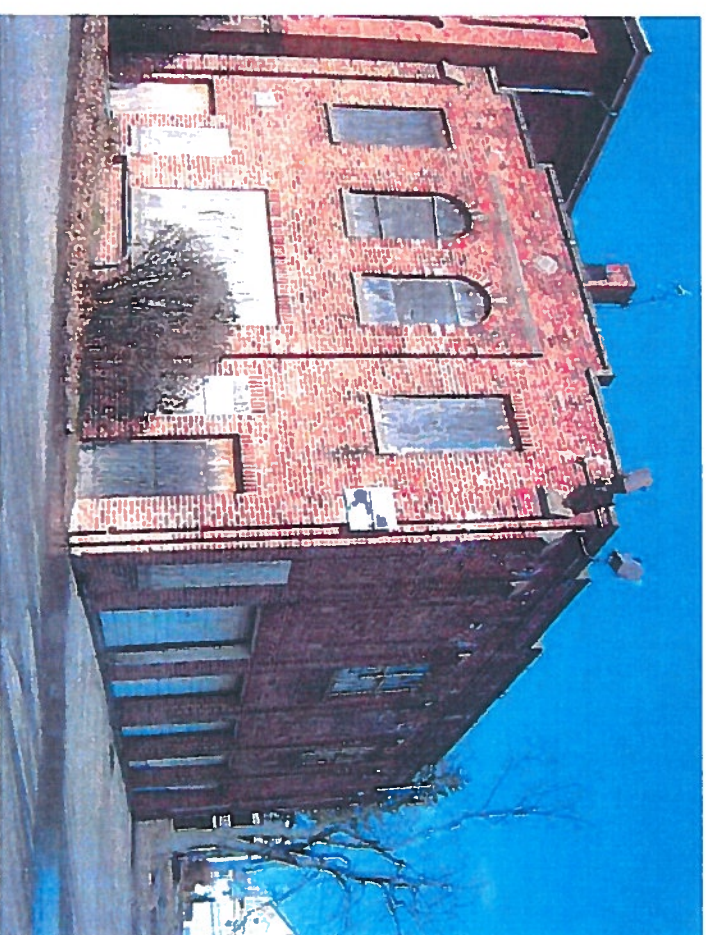
D-2 The building is utilized to some extent but is also somewhat neglected. Site lighting is attached to the building exterior.

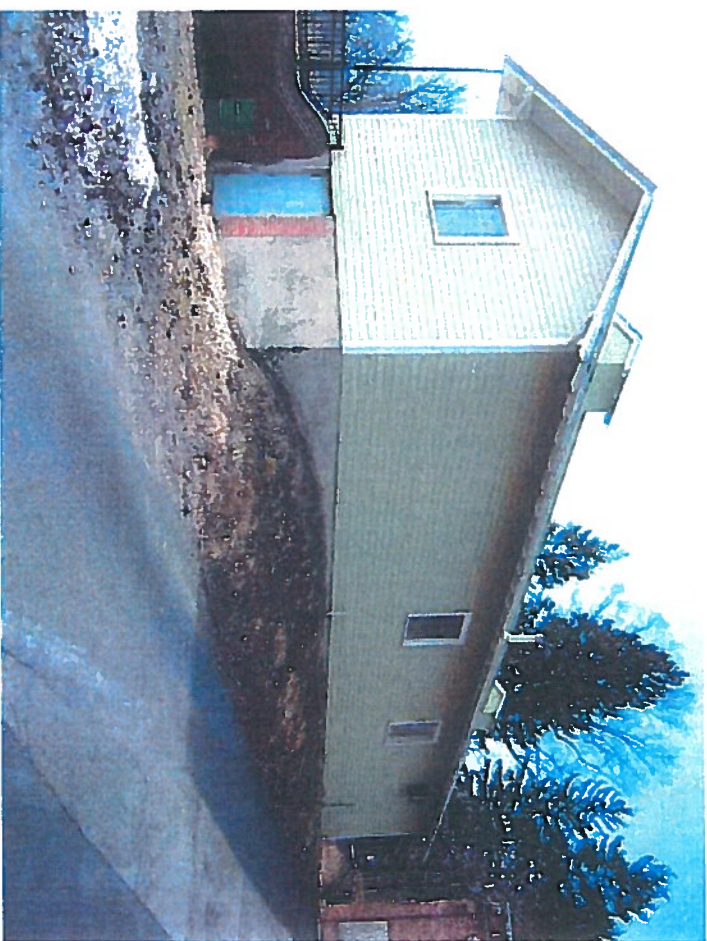
E-2 Each level has a single access. The concrete foundation and wood-framed structure appears to be performing well.
