ENVIRONMENTAL ASSESSMENT

PROJECT NAME: Pliny Street Supportive Housing
PROJECT LOCATION: 102 Pliny Street
Hartford, CT
PROJECT SPONSOR: My Sister's Place
PROJECT CONTACT: Ben Bare, Hartford Housing Authority – (860) 723-8508
ESTIMATED TOTAL PROJECT COST: Construction Funding sources are estimated to be the following:

PHASE I ENVIRONMENTAL SITE ASSESSMENT REPORT
MY SISTER'S PLACE
102 PLINY STREET
HARTFORD, CONNECTICUT

**RE: Pre-Renovation Hazardous Building Materials Inspection Report
102 Pliny Street
Hartford, Connecticut
Eagle Project No. 21-175.10T1**

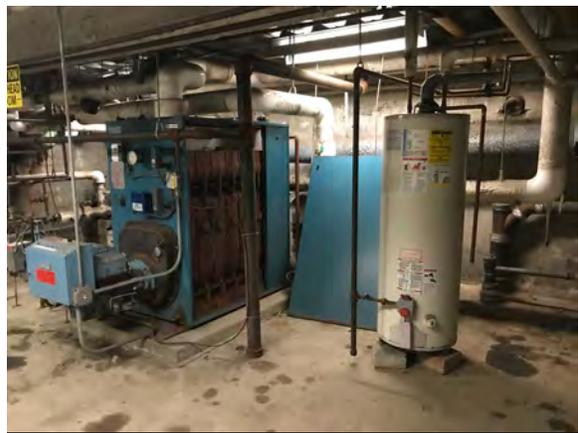
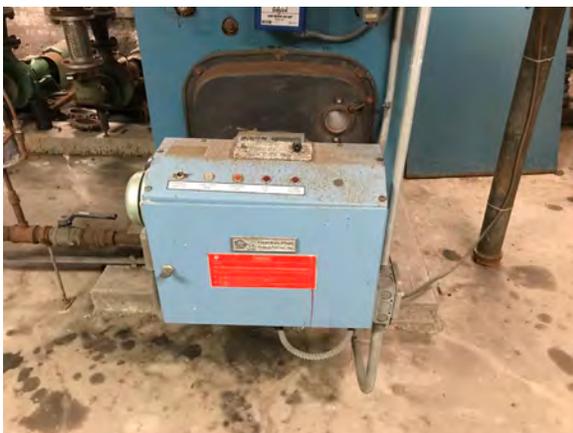
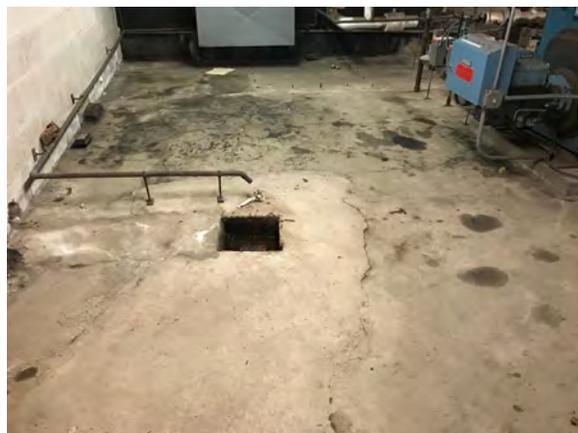
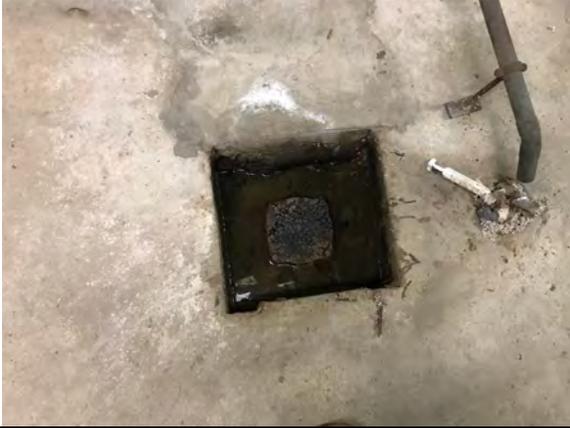
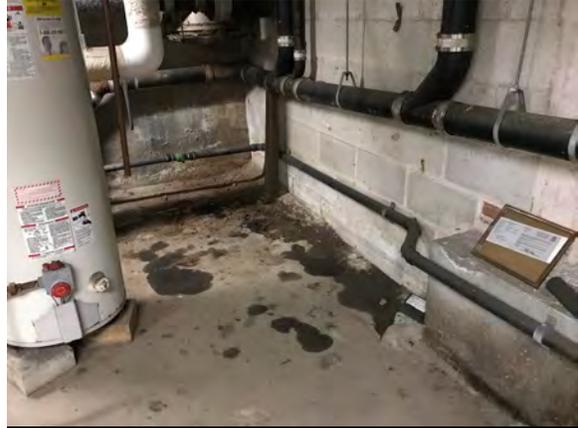
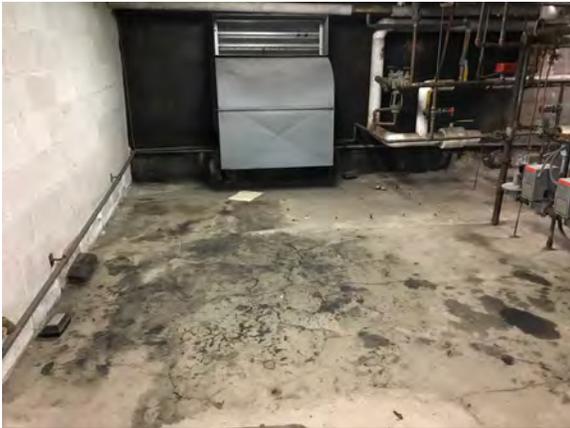
Multiple catch basins were observed in the parking lot. One floor drain was observed in the Boiler Room of the Site building. No sumps or pools of liquid were observed during the Site visit.

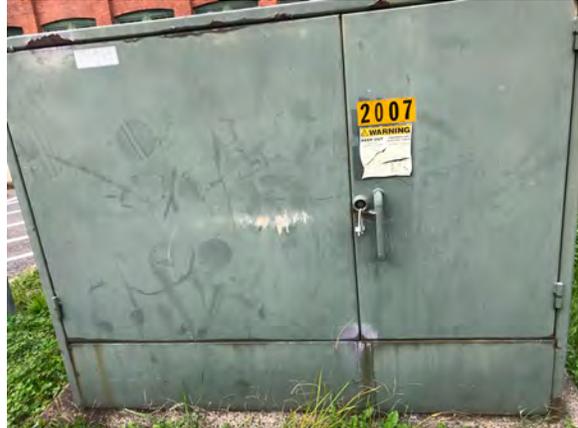
Photo #10	Pad-Mounted Electrical Transformer
-----------	------------------------------------

One pad-mounted electrical transformer was observed on the Site property. No label was observed indicating the PCB content of the dielectric fluid within the transformer. No staining or other evidence of a dielectric fluid release was observed during the Site inspection.
