Environmental Assessment Determinations and Compliance Findings for HUD-assisted Projects 24 CFR Part 58

Project Name: Mary Shepard Place, 15 Pavilion Street, Hartford, Connecticut (HUD Property Disposition application) (herein noted as Project Area)

Project Location: Mary Shepard Place, 15 Pavilion Street, Hartford, Connecticut (**Attachment A**)

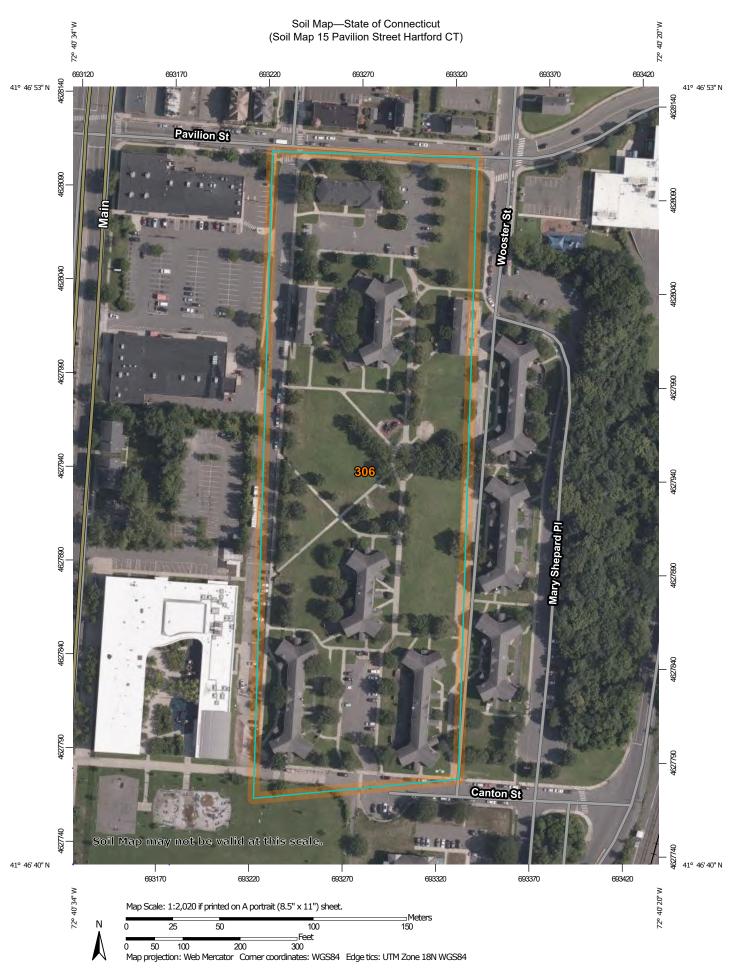
SOIL MAP

_
	surface and grades downward into rhythmically bedded silt and clay varves (lake-bottom deposits).
	According to the CTECO Soils Map, the property is mapped as the Udorthents-Urban land complex, indicating the soils on the property have been altered due to development.
	The project area gently slopes down to the east, towards the Connecticut River.
	Best management practices will be followed during demolition and construction to avoid erosion and control stormwater flow.
Hazards and Nuisances including Site Safety and Noise	The existing structures are currently used as multi-family residential dwelling. No natural hazards or manufactured site hazards were noted. The project is located in the 8-Hour Ozone (2008) and 8-Hour Ozone (2015) Nonattainment areas. Nonattainment areas must have and implement a plan to meet the standard, or risk losing some forms of
	federal financial assistance. The proposed action of demolition and new construction of residential buildings which will remain as multifamily residential buildings will only slightly affect the amount of vehicle traffic at the property and therefore will not have a harmful effect on the 8-hour Ozone levels.
