MASTER PLAN

HARTFORD BOTANICAL GARDEN AT COLT PARK

December 3, 2007

Limited Condition Survey (BVHIS)

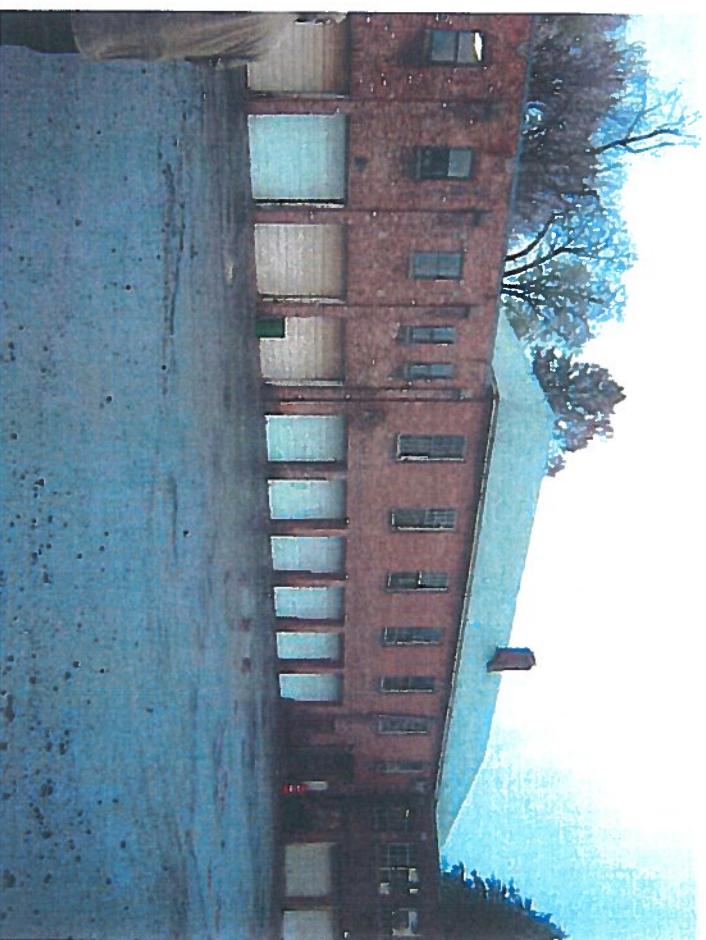
C-2 The rear of the Maintenance Building shows two stories along with the continuation of the building going off to the right.

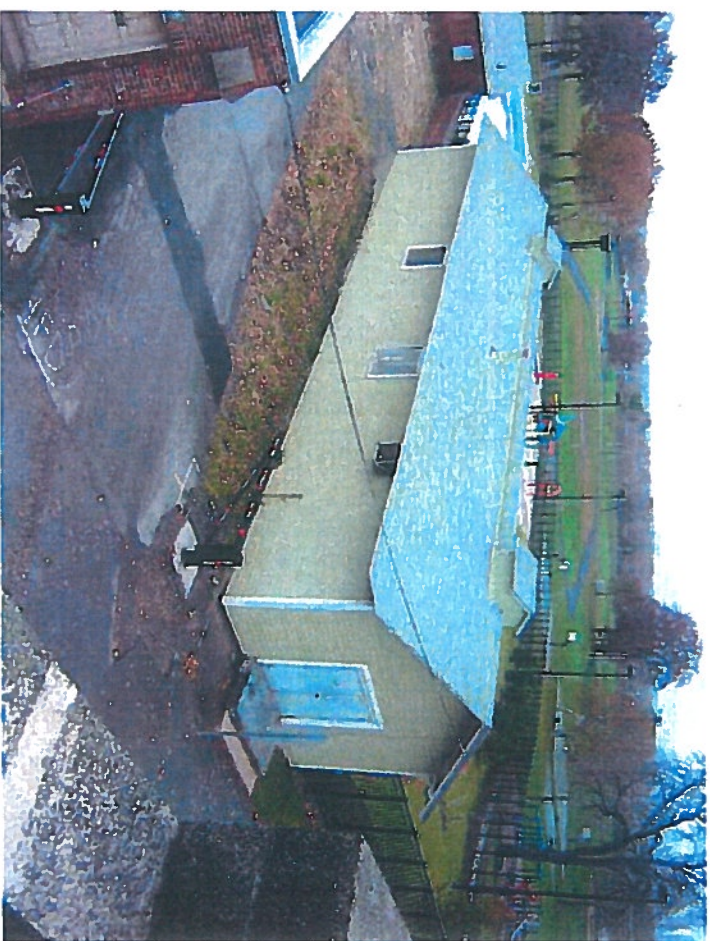
E-1 The Ice House has a simple roof and a full basement.
