## **MEMORANDUM**

Date: April 29, 2020
/ Hesketh, P.E.	
FC Application Review	
	nk Dellaripa, P.E. k Casparino / Hesketh, P.E. Francis – Water Quality Basin Remediation FC Application Review 73

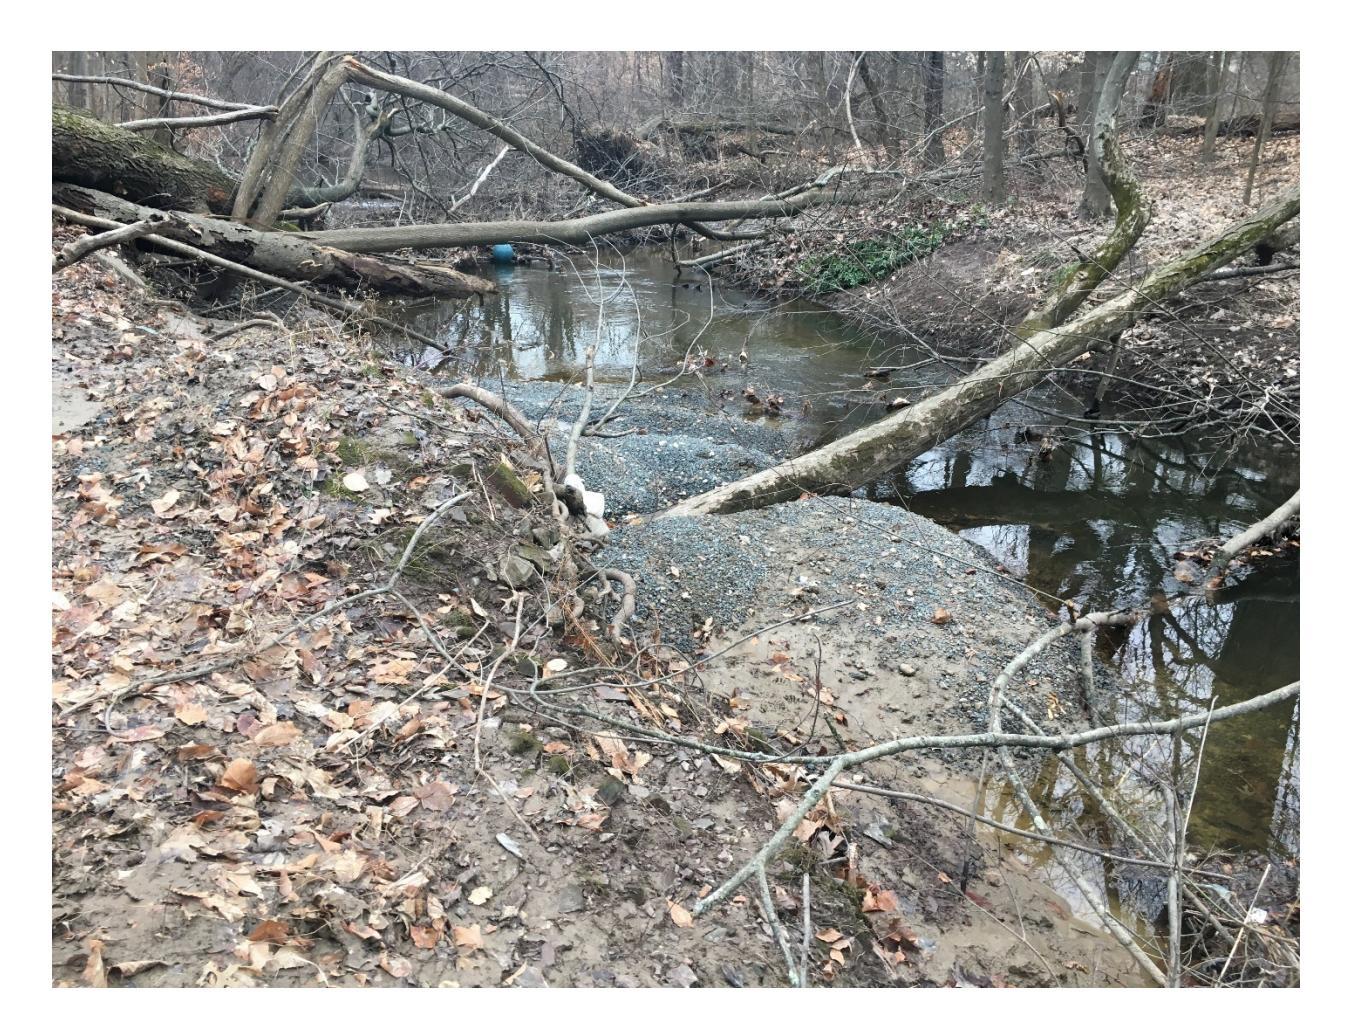
By inspection, it is quite obvious through field identification, what materials have eroded from the wall and eroded channel and been deposited in the river and along its banks. The materials are a mixture of fill soils and native lacustrine soils mixed with processed crushed stone, wall materials and debris from previous construction practices on the slope (from prior site

development). The deposition of the materials in the river can be seen in the attached photograph.

Photograph of materials deposited in the Park River as a result of the wall failure and washout, as viewed south along north limits of material deposition.

edge will be restored to the pre-collapse (2017) condition. Soils, sediments and debris deposited in the river will be removed to restore the pre-collapse condition of the river channel. It is estimated that approximately 75 cubic yards of materials will be removed from the river channel and along its bank to restore the channel and its banks up to elevation 52± to its 2017 condition. The area of deposition in the river and along its banks is estimated to be approximately 30 feet long, 12 feet wide and up to about three feet deep.

Erosion control measures to be implemented during removal of materials in the Park River and its embankment include:

- Work scheduled during low flow conditions (no rainfall forecast for 48 to 72 hours)
- Installation of turbidity curtain in river to isolate work area.
- Removal of sediments and temporary deposition outside of river flood plain to allow dewatering
- Upon dewatering, removal of dredged materials from project site.
- Immediate restoration of finish grade, topsoiling, seeding and installation of erosion control blankets along disturbed areas not to receive further work.
- Immediate installation of drainage improvements, stormwater outfalls, rip rap outlet controls and rip rap stabilizations from river's edge to area outside of flood plain.
