STANDARDS FOR RESTORATION & GUIDELINES FOR RESTORING HISTORIC BUILDINGS

Restoration

Standards for Restoration

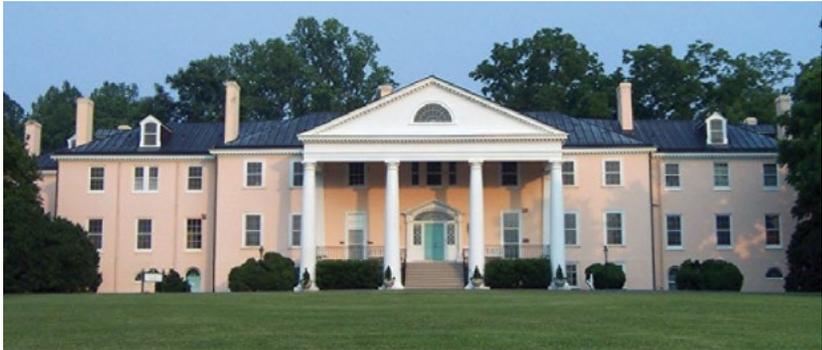
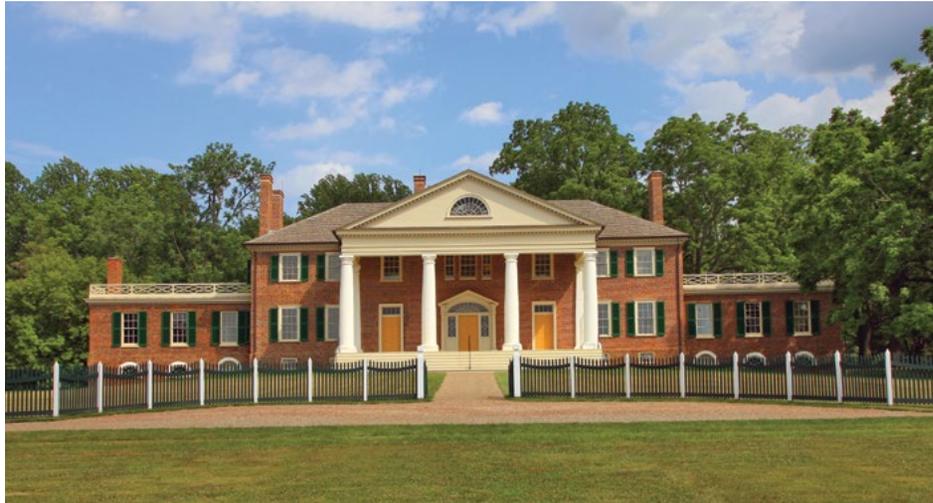
[1] (a) When it was acquired by the National Trust for Historic Preservation in the 1980s, Montpelier in Montpelier Station, VA, the home of James and Dolley Madison, had been much altered and enlarged since it was first constructed. Based on historical documentation and research, Montpelier was accurately restored to its 1820s appearance when the president and his wife lived there (b). Photos: Courtesy of The Montpelier Foundation.

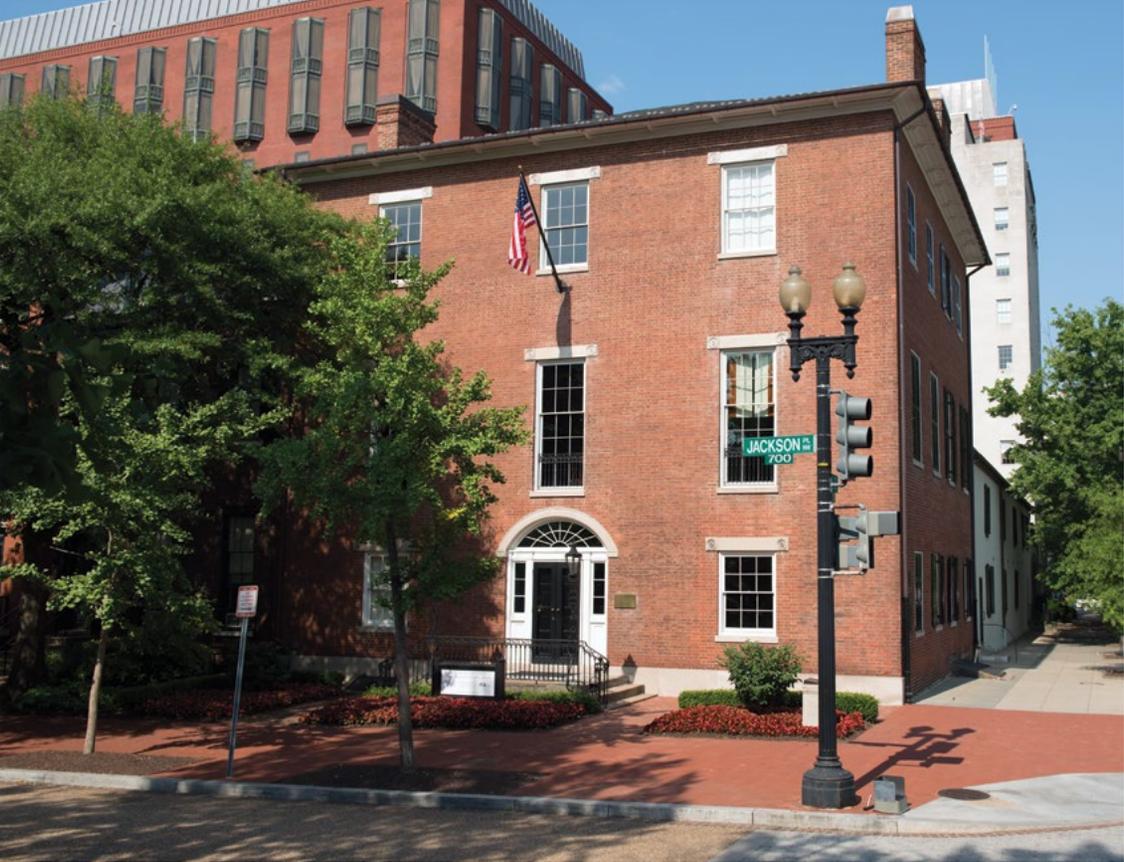
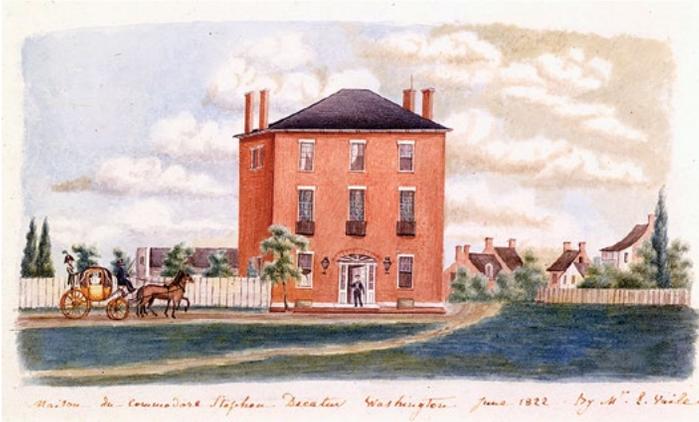
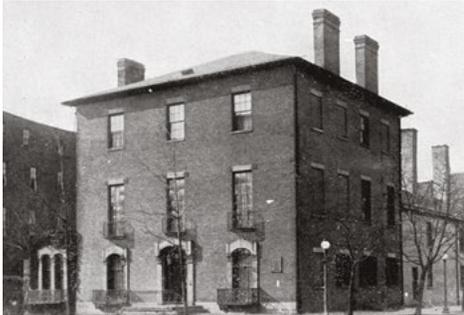
[2] (a) Decatur House in Washington, DC, was designed by William Henry Latrobe and constructed in 1816. (b) In the late-19th century, the façade was “modernized” by removing the limestone lintels on the first floor and replacing them with decorative sandstone lintels in the style of the period. (c) In the mid-20th century, the house was brought back to its original appearance based on historic documentation. Photos: The White House Historical Association and Decatur House, a National Trust Site.

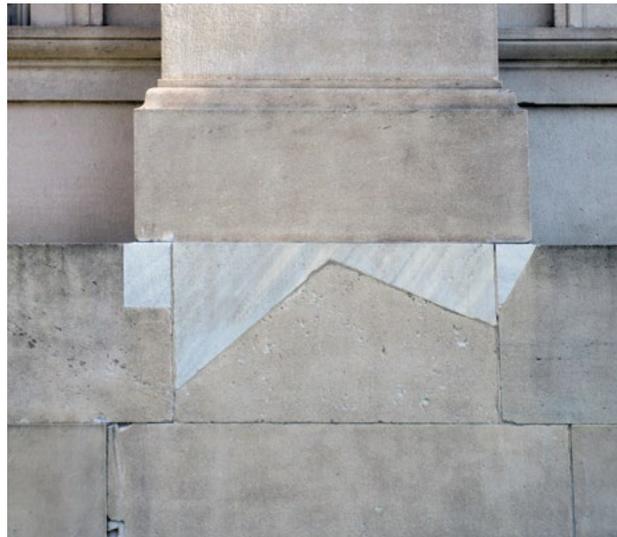
[3] **Not Recommended:** Although the Dutchman stone repair has been well executed, the replacement stone is not a good color match.

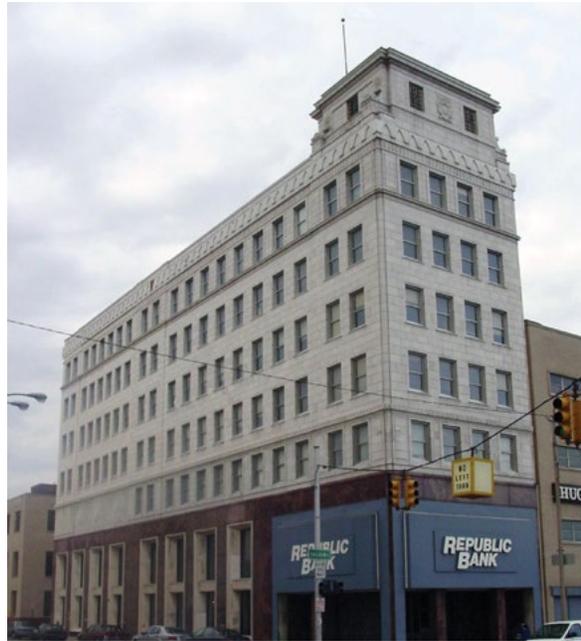
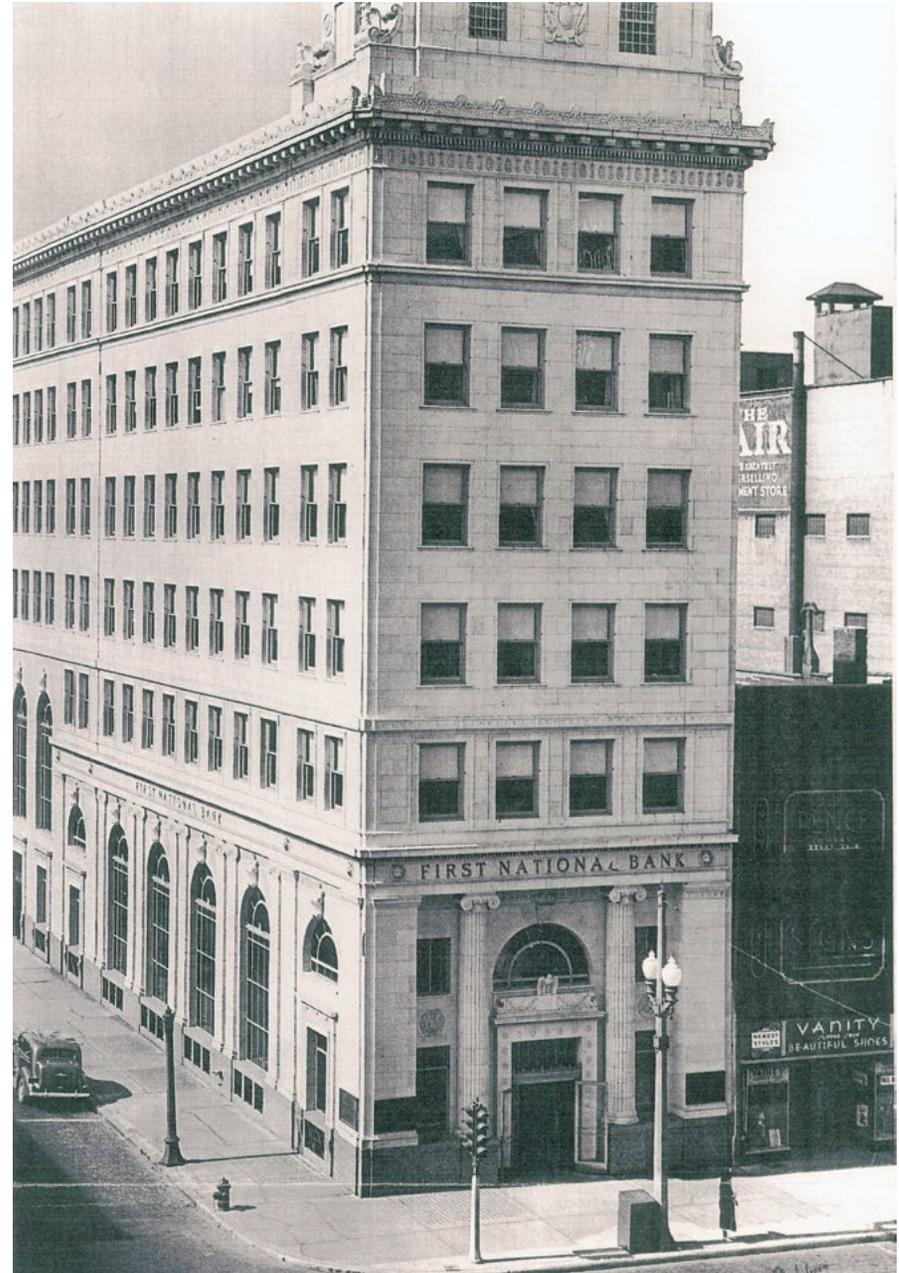
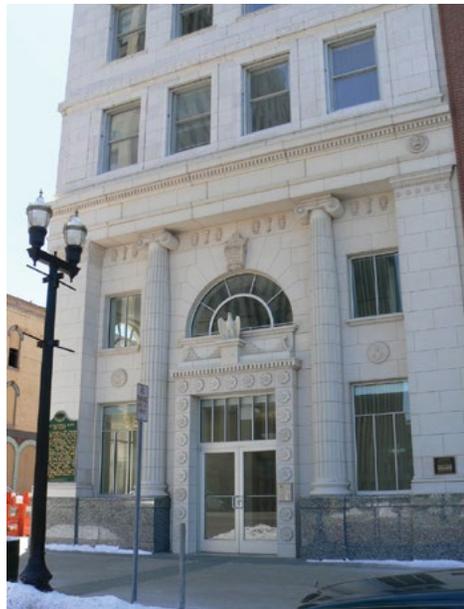
[4] (a) Over the years terra-cotta cladding had been replaced on the lower floors of this early-20th century bank building with a storefront and incompatible windows. (b) A 1936 photograph of the building provided the documentation to restore its historic appearance. (c) Glass fiber reinforced plastic (GFRP) was chosen as a substitute material, and samples were made in a variety of colors and textures to obtain the best match for the missing and damaged terra cotta. (d) This photo taken after restoration shows that the GFRP replacements successfully blend in with the original terra cotta. Photo (d): Blamonet at English Wikipedia.

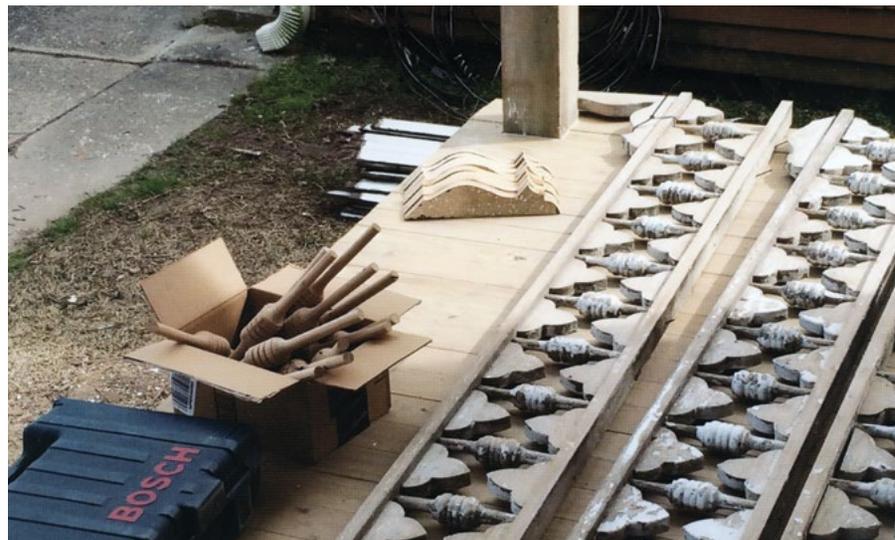
[5] New wood trim pieces were milled to match the few remaining historic features to replace those that were missing.

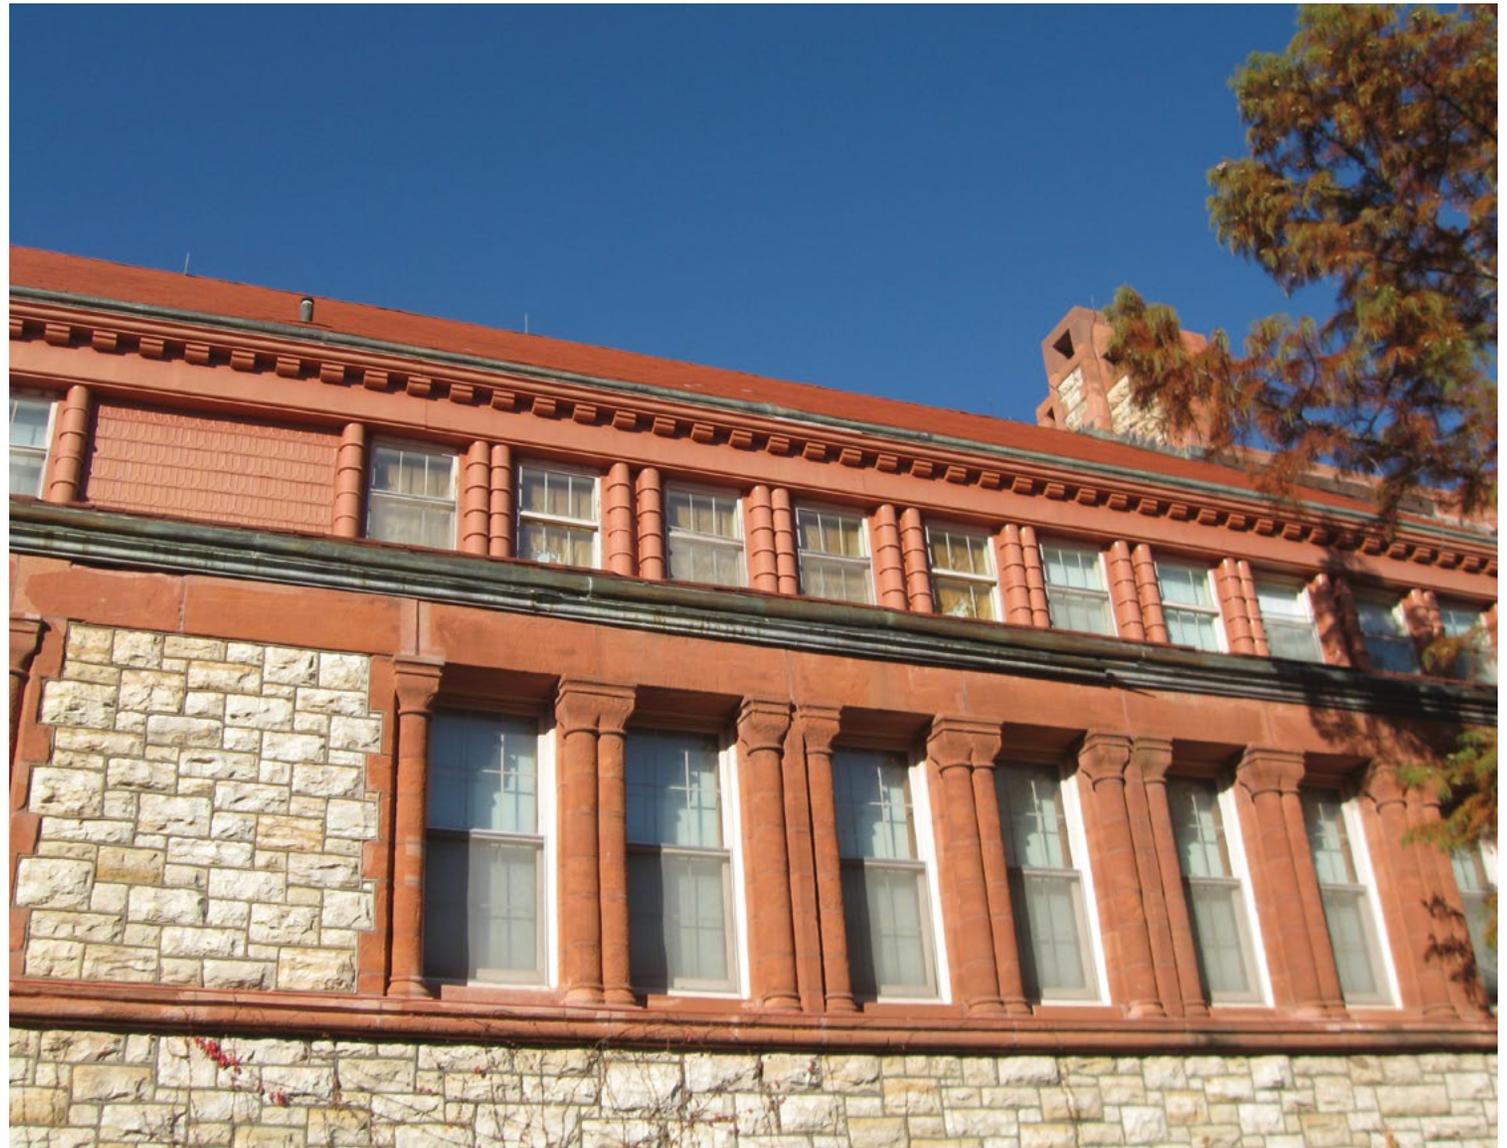
[6] Preliminary work before starting restoration revealed that the columns and the decorative shingles ornamenting the top floor of this historic building were fabricated of metal to imitate the red sandstone used elsewhere on the building.

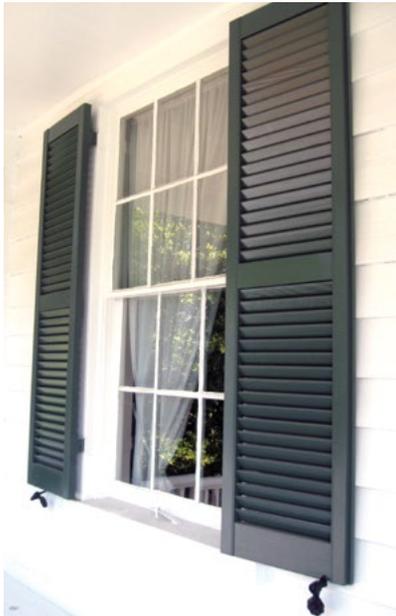
[9] Historic window and shutter hardware such as that shown here should be retained and repaired in a restoration project.

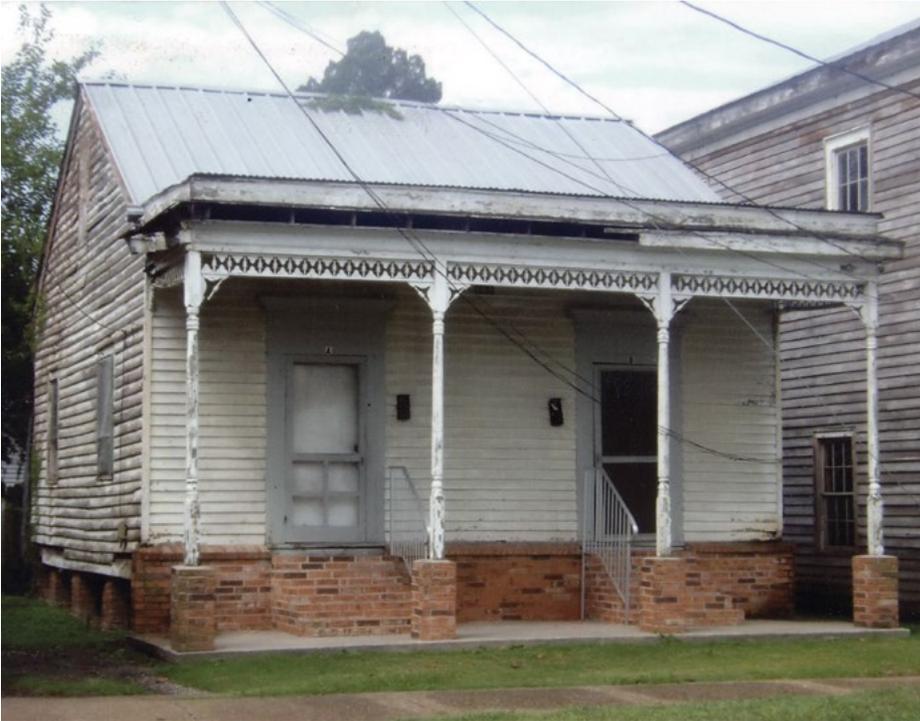
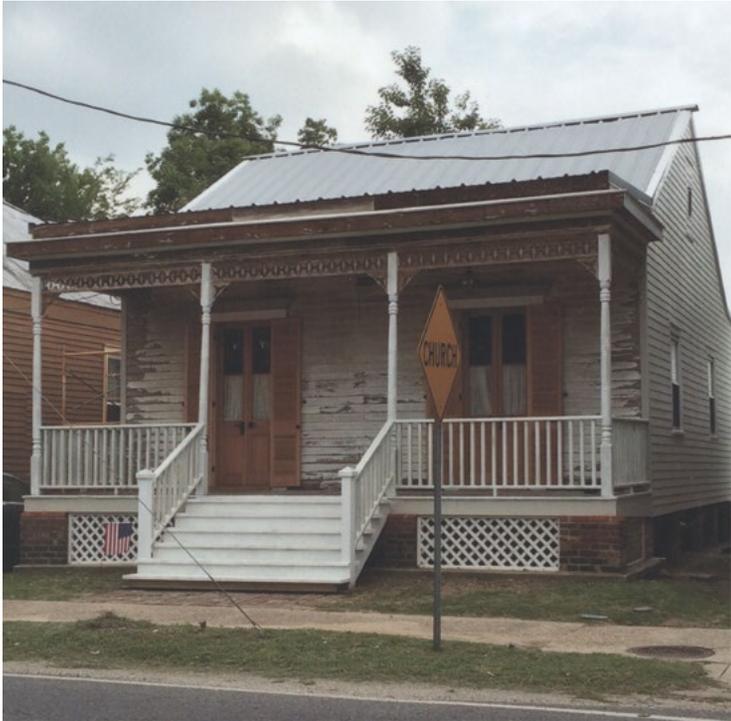
[10] (a) The entrance of this house had been altered over the years, including removal of the porch floor and steps. (b) This photograph shows the house after the porch and steps were restored to their historic appearance.

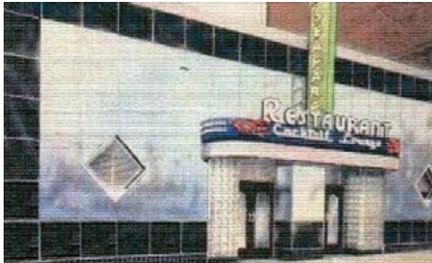
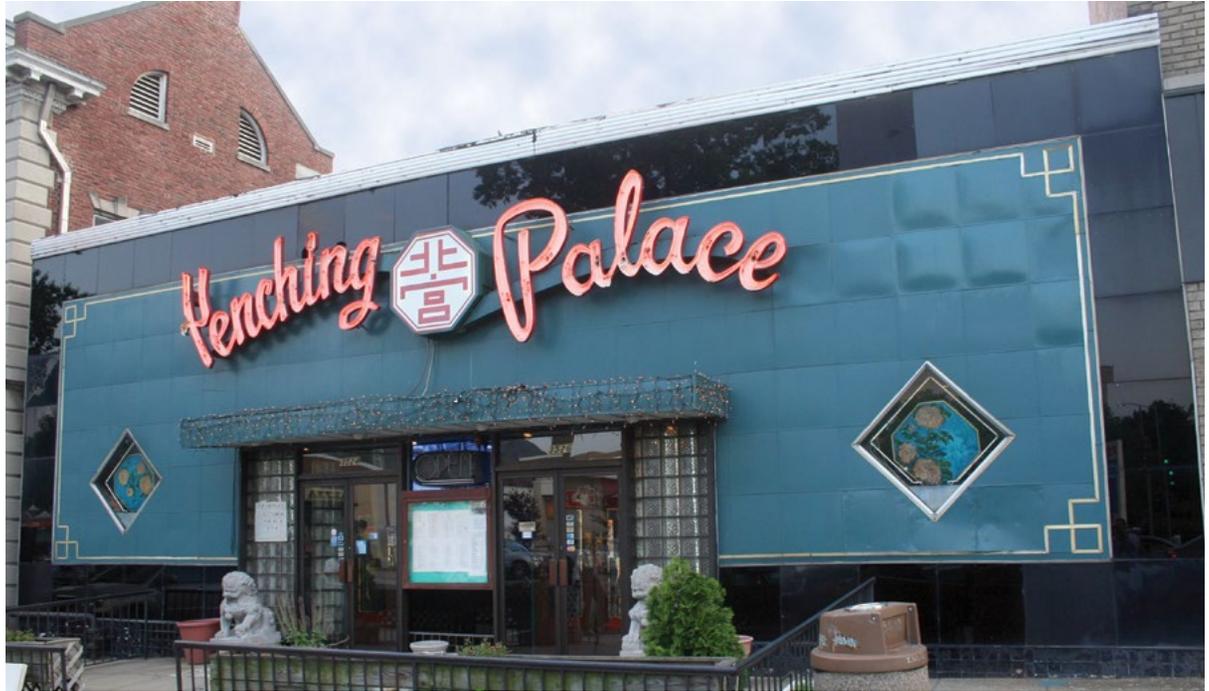
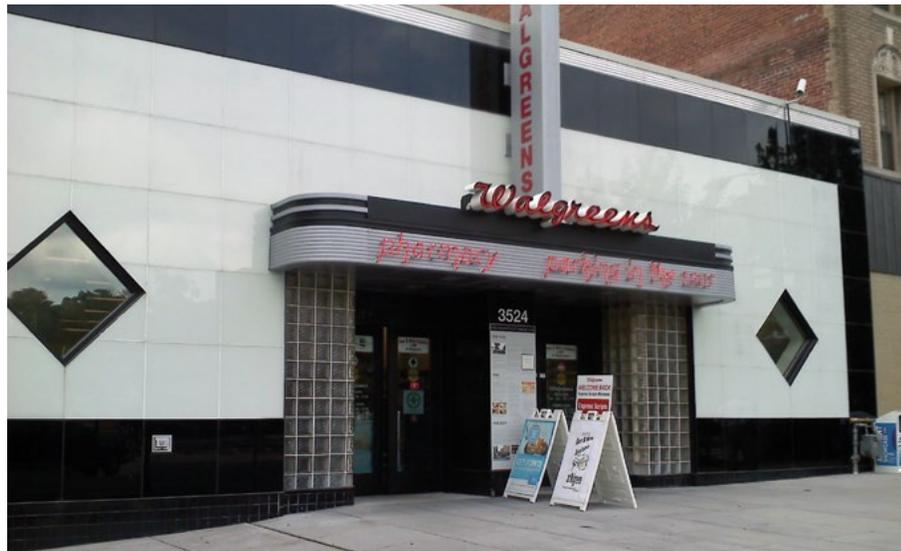
[11] (a) Some of the materials on the front of this historic building had been previously replaced, but the façade retained its essential distinctive features and design. (b) A vintage postcard of the building (far left) provided sufficient documentation to restore the façade to its historic 1945 appearance, using spandrel glass as a replacement for the original Carrara glass (c). *Photo (b): Courtesy Kelsey & Associates.*

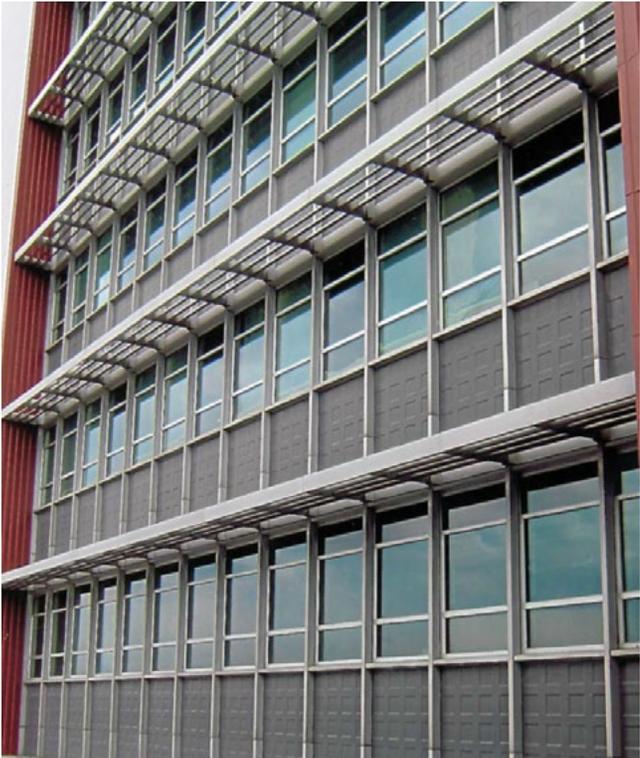
[12] This historic curtain wall features a distinctive variety of panel types which must be repaired or replicated in a restoration project if any are damaged or missing.

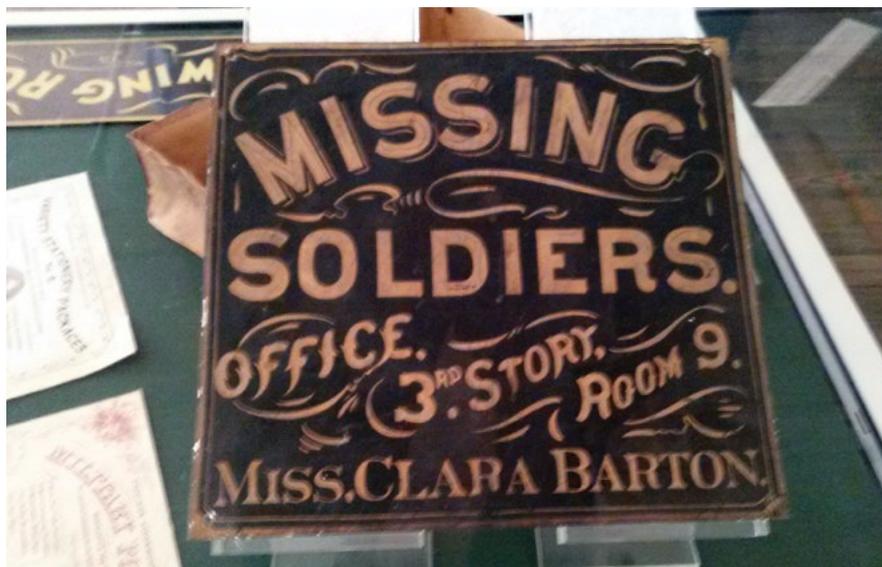
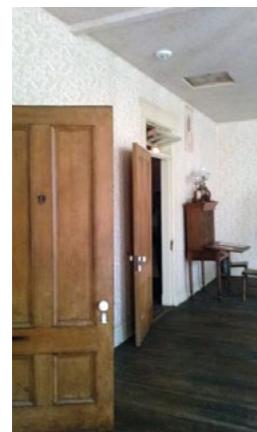
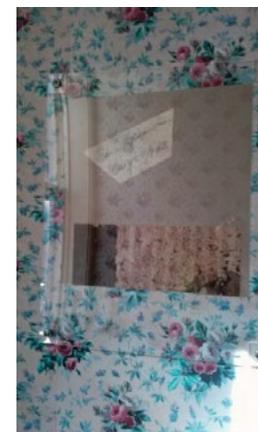
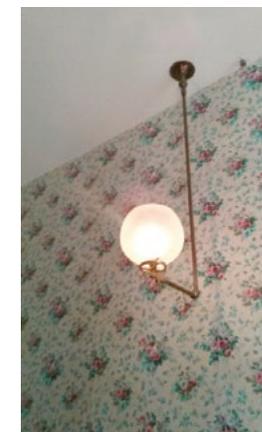
[13] (a) In the 1990s the Missing Soldier's Office—established by Clara Barton at the end of the Civil War—was discovered still extant on the third floor of a building in Washington, DC, that was slated for demolition. The office was restored to its historic appearance using physical and documentary evidence. The original numeral '9' is still on the door to the office, and wall paper was reproduced from scraps found on the walls (b-d).

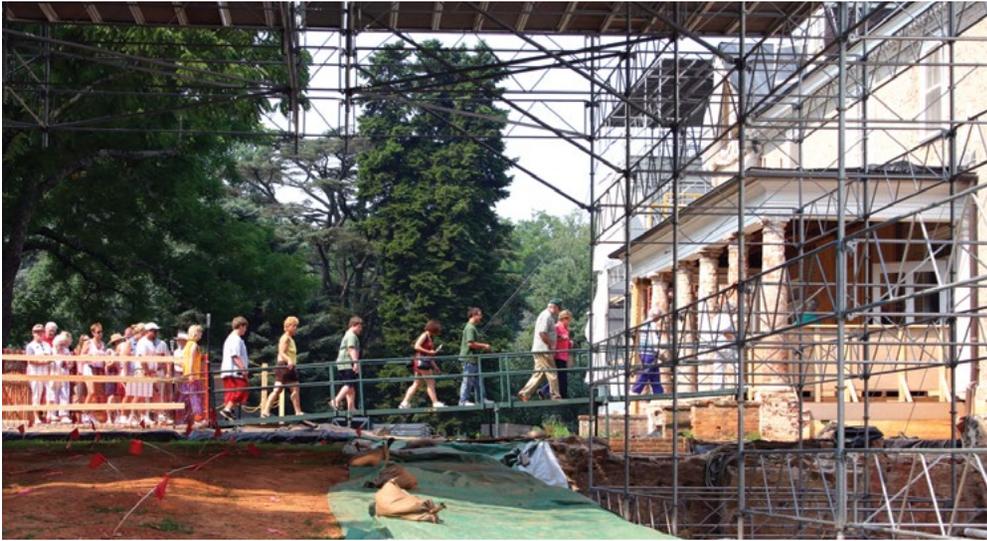
[16] Archeological investigation of the property was undertaken to ensure accuracy of the restoration of Montpelier. Photo: Courtesy of The Montpelier Foundation.

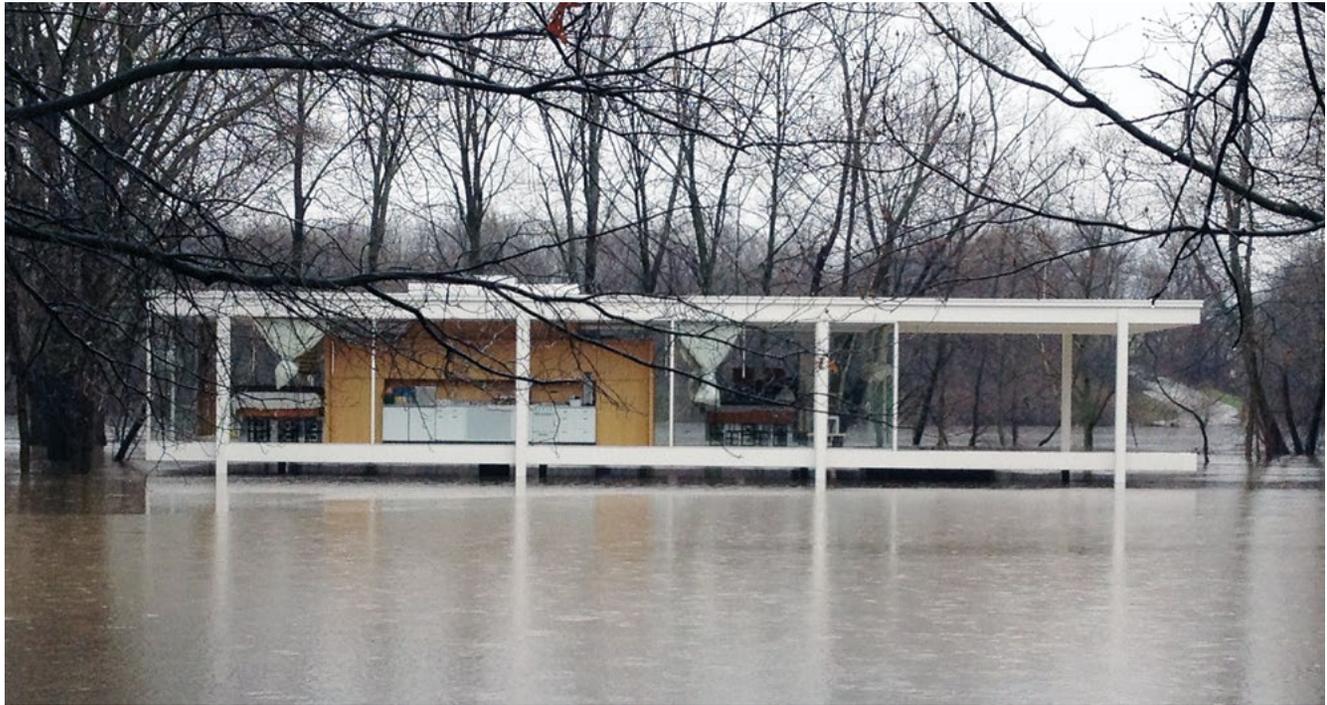
[19] The 1951 Mies van der Rohe-designed Farnsworth House, Plano, IL, was built close to the Fox River, which is increasingly prone to floods. To preserve the house in its original location, historic preservation architects and engineers continue to explore ways to protect it from the flooding, including a possible system that would lift the house above the flood waters and lower it back to the ground. *Photo: Courtesy Farnsworth, A Site of the National Trust for Historic Preservation.*

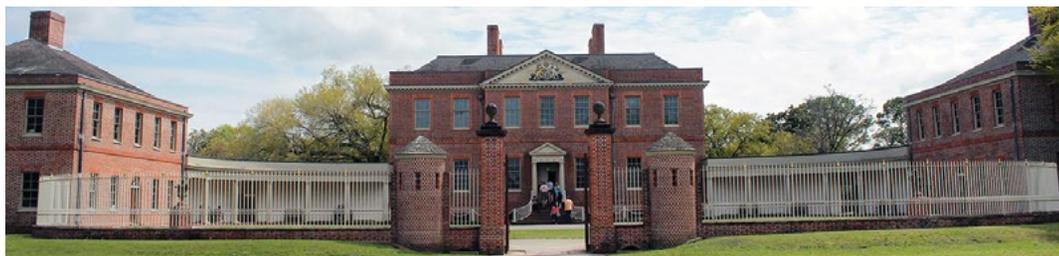
[1 a-b] Tyron Palace, New Bern, NC, was designed by John Hawks in 1767 for Governor William Tyron. It was completed in 1770, but destroyed by fire in 1798. The palace was reconstructed in 1959 based on the original plans, and on its original foundation, which was found 5 feet below the street, with the help of the 1767 drawing. *Photo: Courtesy Tyron Palace, New Bern, NC. Drawing: Courtesy of the State Archives of North Carolina.*

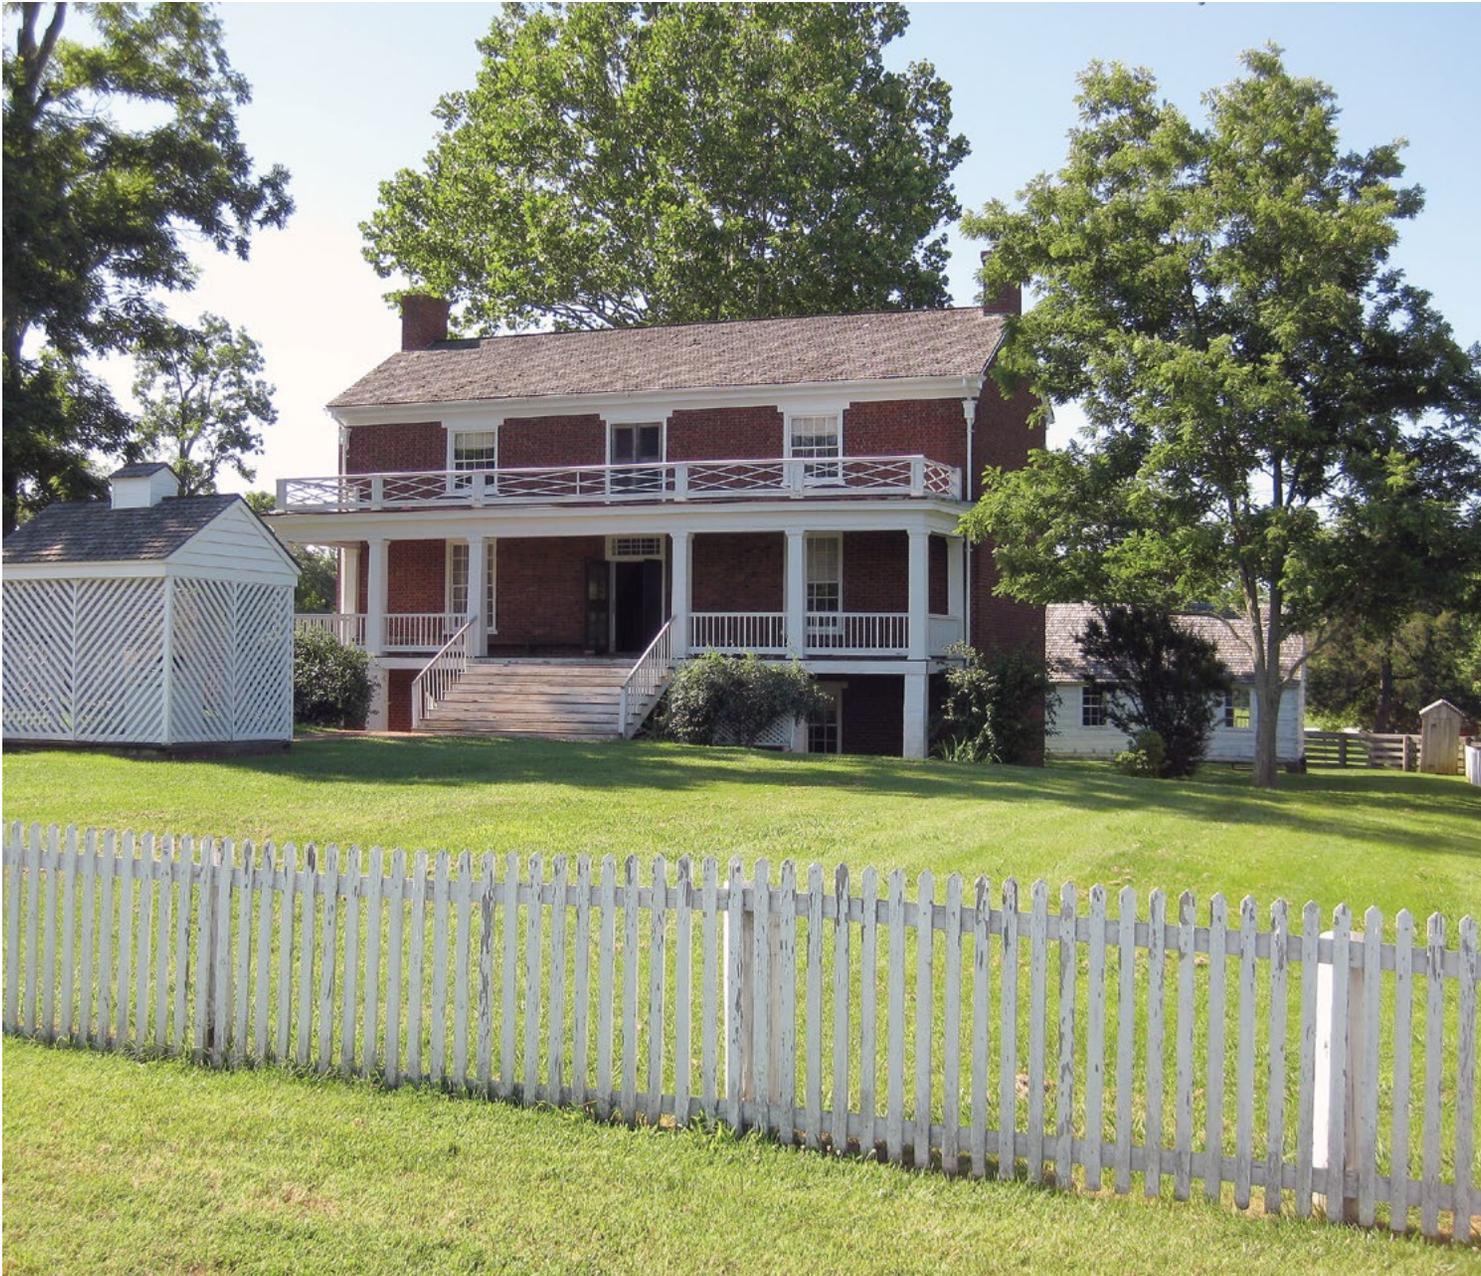
[4] The McLean House, where Robert E. Lee surrendered to Ulysses S. Grant, is located on the site of the battlefield—now part of Appomattox Courthouse National Historical Monument (VA). Several years after the end of the Civil War, measured drawings were made of the house before it was dismantled to be moved to Washington, DC, where it was to be reconstructed as a tourist attraction. This scheme never came to fruition, and the dismantled pieces gradually disappeared. The house was accurately reconstructed in 1949 on the original site based on the measured drawings.

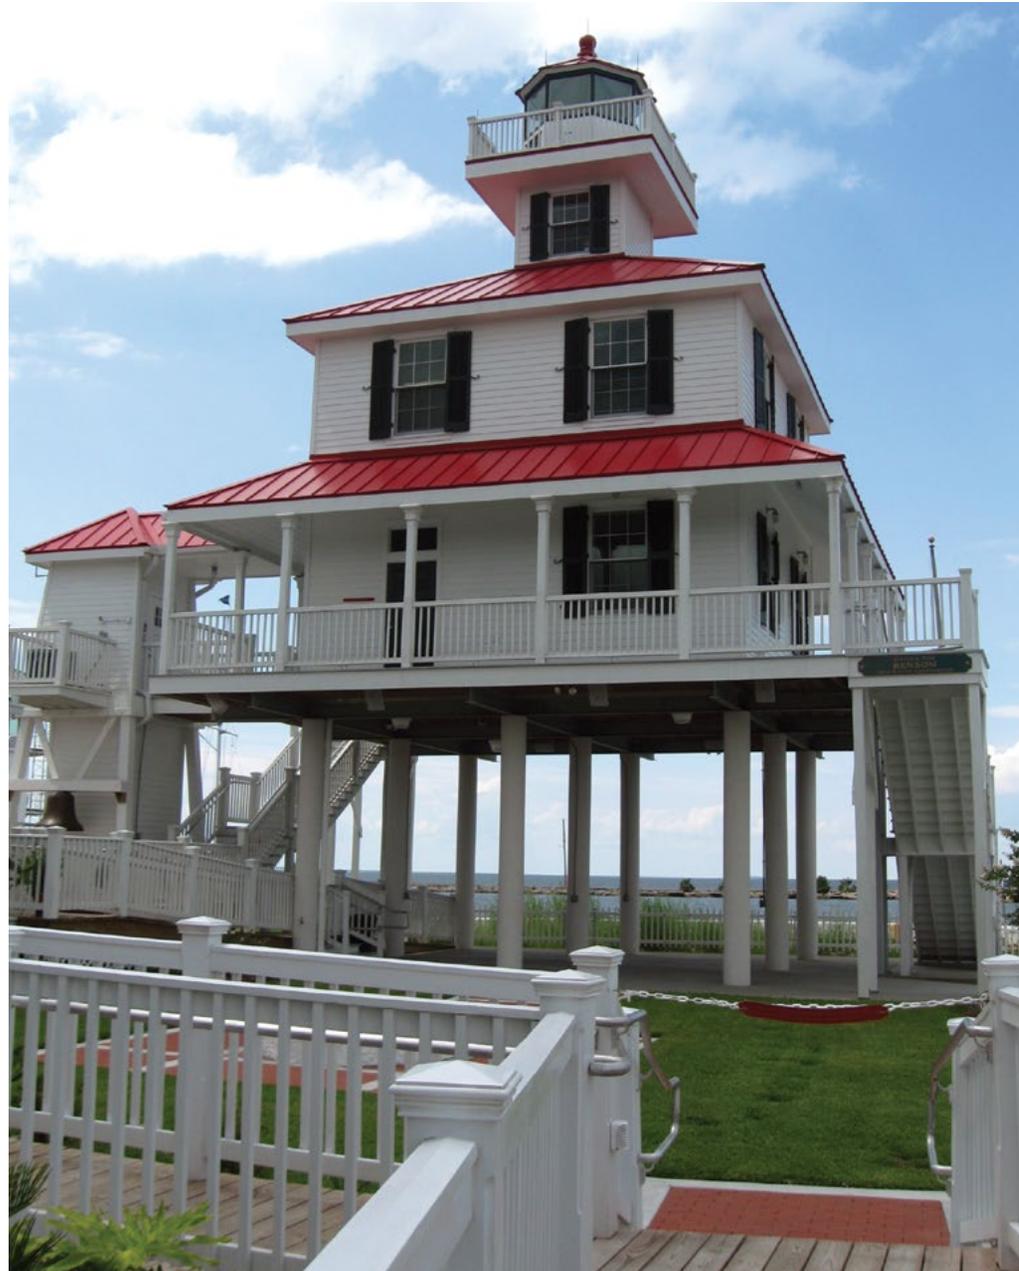
[6] This lighthouse on Lake Ponchartrain in New Orleans was reconstructed after the historic 1890 lighthouse was destroyed by Hurricane Katrina.

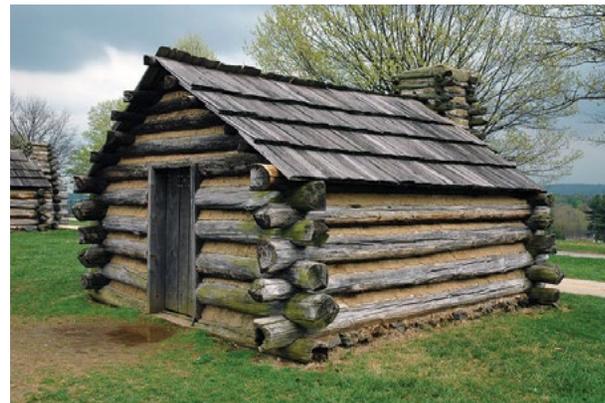
[7] The Muhlenberg Brigade Huts are reconstructions of nine log huts erected in 1777 at Valley Forge during the Revolutionary War. They have been reconstructed on the historic road with logs cut with modern power tools and finished with cement, unlike the original logs which were hand hewn and finished with traditional chinking. *Photo: Rdsmith4 at Wikimedia Commons.*

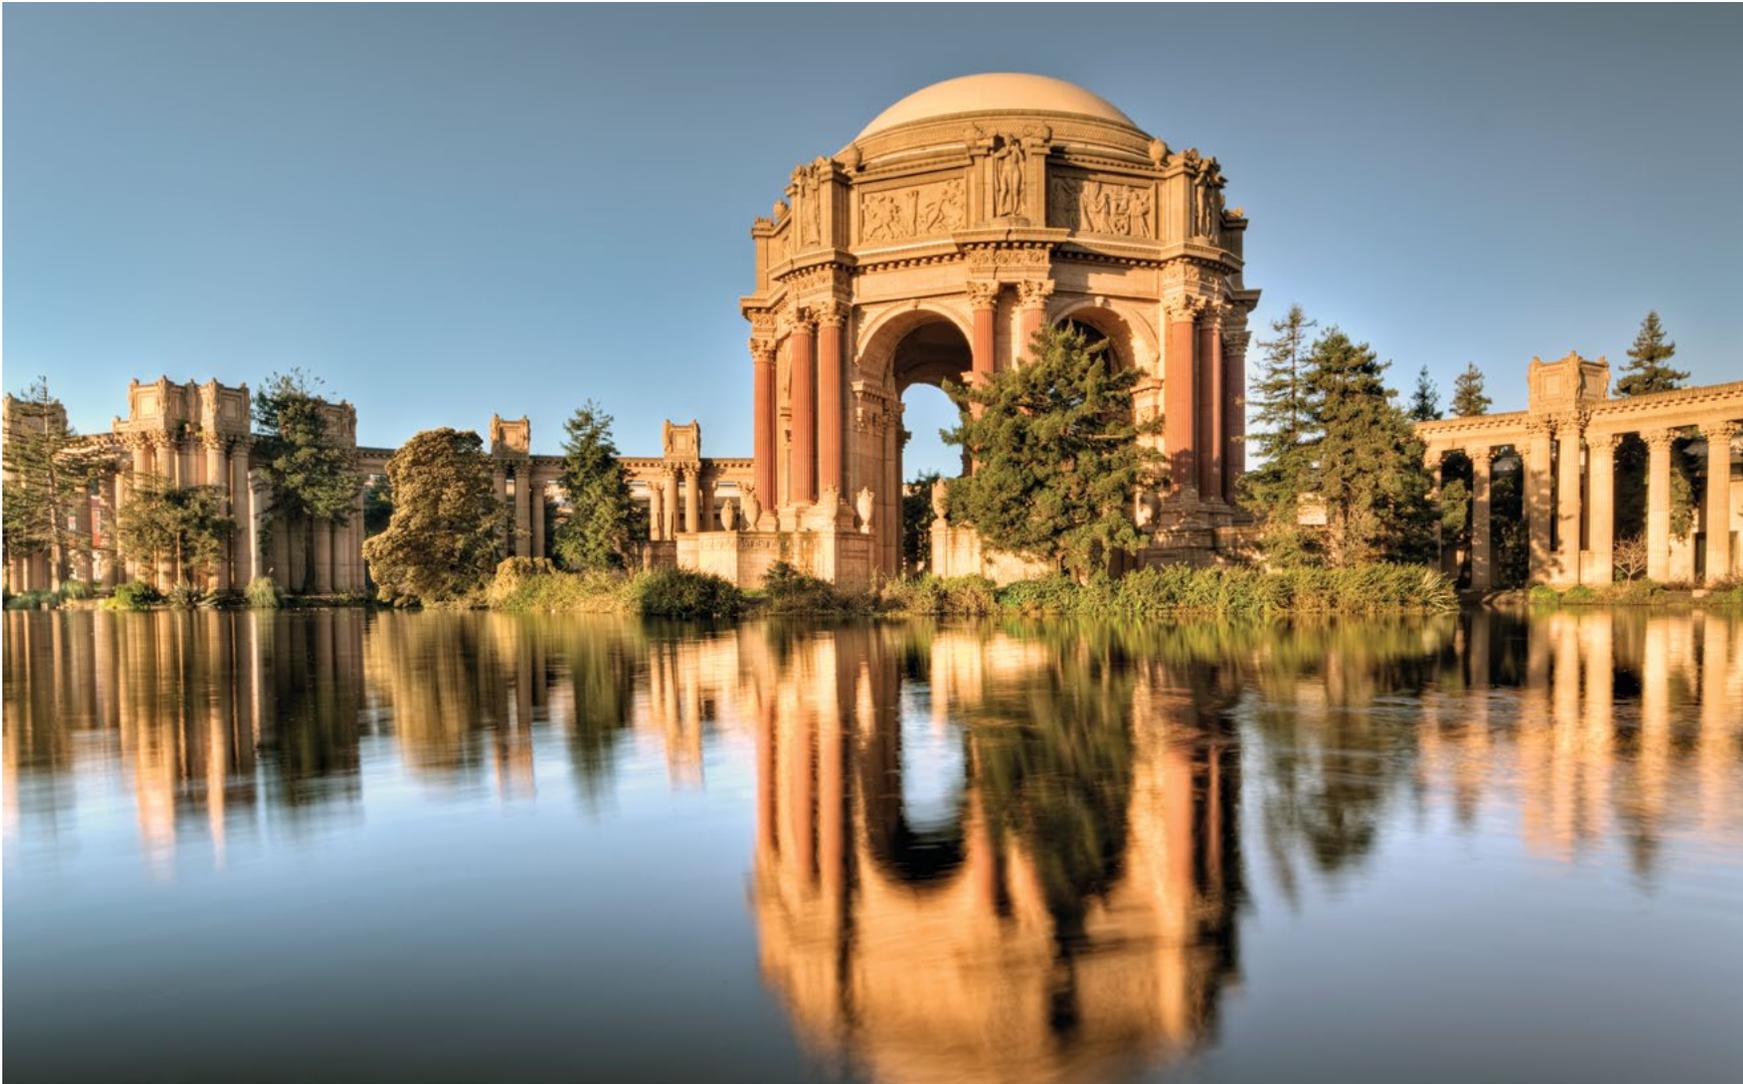
[8] The Palace of Fine Arts was designed by Bernard Maybeck and built for the 1915 Panama-Pacific Exposition in San Francisco. The pavilion was intended to be temporary and, although it had a steel structure, the exterior was finished only with stucco, an impermanent material composed of plaster and fiber. The building was not torn down after the exposition, and it eventually fell into ruin. In 1964, all but the steel structure was demolished, and the building was reconstructed with lightweight poured-in-place concrete. *Photo: KevinIcole at Wikimedia Commons.*
